©Vendor Surveillance Missions

The Notebook of Larry D. Bolton - Mail Stop 1701, Univac, Univac Park, St. Paul

Mission #1, 11/16/65

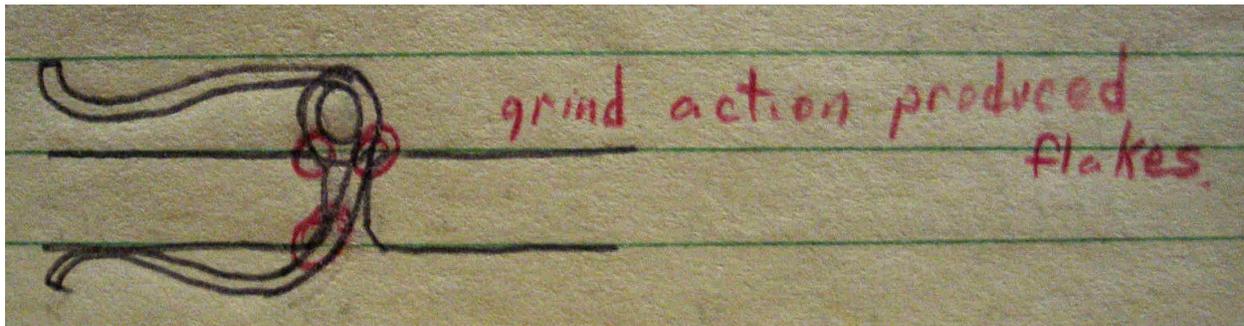
Checked boats for source of metal particles. Found several large flakes which were loosened by forceps. I moved the springs on the fashion used to mount chips on boats. This caused a few pieces of metal to fall on a piece of paper below. Size ranged from 1 very large piece to infinitesimal pieces. Microscopic examination of the boats showed several large flakes ready to fall off.

Boat construction was rather haphazard.
