INTERCOMMUNICATION

SUBJECT: Corrective Maintenance on  
Johnston Atoll

PLACE VISITED & DATES: Johnston Atoll  
10-19-72 thru 10-26-72

PURPOSE OF VISIT: Corrective maintenance to Univac equipment in  
GG-1, GGS-2, and IMS

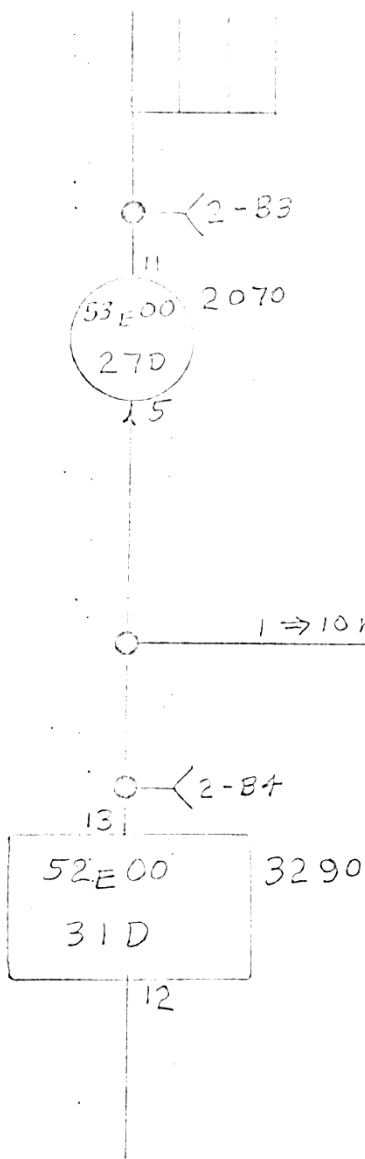
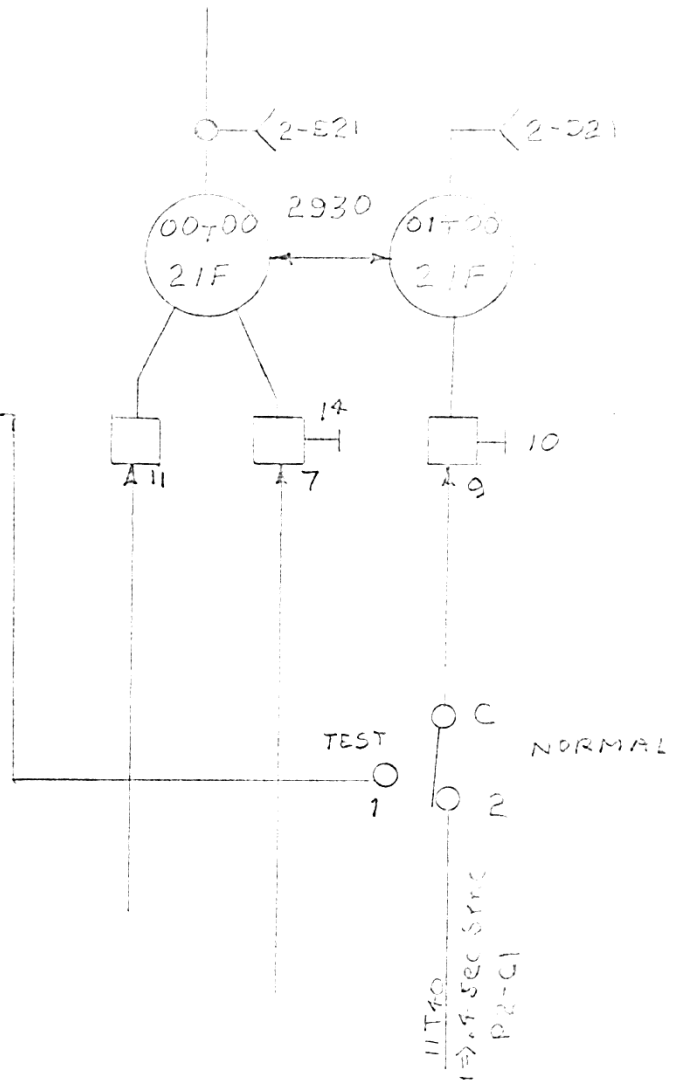
A great deal of difficulty was encountered in troubleshooting the RTD/RIU before a modification was made to allow the computer to receive the time of day every 10 ms. Since this modification consists only of deleting one wire and replacing it with another, a Test/Normal switch would permit much easier troubleshooting. See the attached drawings for details. This in conjunction with a new RTD test would simplify the troubleshooting of this piece of equipment.

1. Install spdt switch.
2. Add a wire from 27D-5 to switch contact 1.
3. Remove the wire on 21F-9 and place it on switch contact 2.
4. Add a wire from 21F-9 to switch contact common.
