# Three Magnetic Drum Memory Artifacts

By Larry D. Bolton

## Introduction

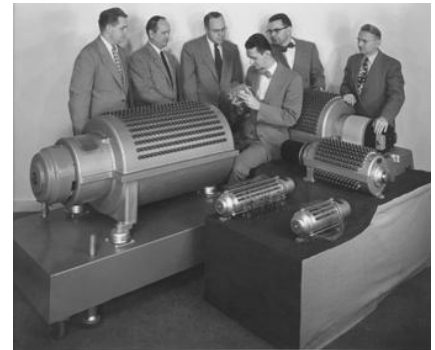
Shown here are several drum memory models in an early 50’s snapshot. The engineers/managers in the photo are identified in section 2.1 of <http://vipclubmn.org/engmemory.aspx>. The drum in the front right resembles the 1119 model. The drum in the front center resembles the 1124 models described hereunder. Each of our three drums is discussed separately on the following pages.

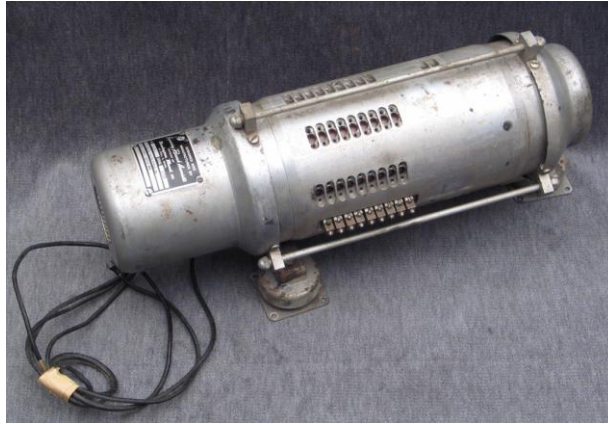
**Model 1119A1, Serial number 106**

This drum is probably the oldest of the three. See Appendix A for some of the observed characteristics of this drum compared to the claimed capabilities of the 1119 family. This drum is in fair condition. It is mounted via three round shock absorbing feet. Two are installed under the motor end and one under the opposite bearing support end. There are fan blades attached to the ends of the shafts under the end covers presumably to aid in bearing cooling.

This particular drum is very unusual in that it has only six rows with milled cavities capable of holding heads and is therefore not fully populated. Each row has nine cavities. In its current configuration, four rows are open with no heads installed. The machine milled cavities in these four rows are all the same. The machine milled cavities in the other two rows are a little different and, as was initially seen, both rows contained permanent magnet heads rather than electrical read or write heads. The view above shows three rows between the bars. The back side has three rows similarly arranged. Measurements of the head locations show that although there are spaces for 54 heads, there are only 18 tracks on a 0.35 inch spacing (2.7 tracks per inch). If we number the tracks 1 thru 18 beginning at the left (motor) end, we notice the rows are staggered. The row just behind the top bar and the middle row in front are slightly left of the other two. The left shifted rows are on the odd numbered tracks, the right shifted rows are on the even numbered tracks. So, the rows alternate between odd and even numbered tracks. Including the two other rows, which are not visible in the photo, three rows of heads share a common set of tracks. The other three also share a common set on an alternating basis with the first set. The bottom row in back also has a set of magnet heads like the bottom row on the front. From this, it appears that each track has two read/write heads and one permanent magnet head. Perhaps one head would write, the second would read, and the permanent magnet would erase, all in one revolution. Looking at the drum from the motor end and assuming 0 degrees is at the top bar, the rows for track 1 are spaced at 70, 260 and 335 clockwise degrees and the track 2 rows at 25, 100, and 290 degrees. The magnets are placed in the 100 and 260 degree rows. Thus the spacing between the two read/write head rows is 95 degrees for both the odd and even numbered tracks. Based on the spacing of the rows and rpm of the motor, a read would occur 1.50 msec after the write. The timing of the erase depends on whether it is an odd or even track number but apparently this time does not matter. The numbers are the same regardless of the direction of rotation of the drum. Only about half of the drum area is used for head mounting. There are no heads in the bottom third of the case. There are two more rows of two head mounting spaces at the support end of the drum. These are at the far end of the 290 and 335 degree rows. One row of these can

be seen in the photo at the right end behind the top bar. The other row is just behind this one. Presumably these locations were used for timing or marking tracks.

The presumed “erase” heads (See Appendix B) are made from a permanent magnet. They are roughly in the form of a cylinder about 0.25 inch in diameter. The magnetic end is also shaped so there is a small gap and the head is about 0.025 inch wide, same as the read/write head. But they appear to be positioned about 0.1 inch off of the drum surface.

The function/purpose of this drum is unknown but proposed applications include a register, delay line, or data transfer/sharing between two computers.

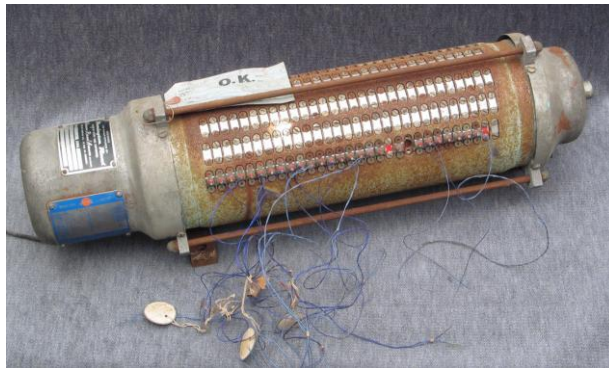
### **Model 1124A1, Serial number 7**

See Appendix A for characteristics of this drum and advertised capabilities of the 1124 family. This drum is in the worst condition of the three in that the chrome (?) plating on the casing has eroded or has mostly fallen off and the surface has a coating of rust. The shaft does turn but it will not coast. This drum is also mounted via three round shock absorbing feet. Two are installed under the motor end but the one under the bearing support end is missing. The drum has a blue OK tag attached. The date on the tag is 2/25/58. Comments written on the back of this tag are as follows: “Head C19 had rubbed depositing loose oxide inside of shroud. This was removed as much as possible. If further difficulty is experienced it will be necessary to overhaul this drum completely.”

This drum has six rows of thirty milled head locations. All rows are in the top half of the case. It is not known how the rows are identified but there is only one row of the six with heads installed. This drum, when initially seen, had 27 heads installed in one row. In the view above, row C is presumed to be the row with heads installed. The two rows above are presumed to be rows A and B. On the back side, under and to the rear of the blue OK tag, are three more rows spaced like the A thru C rows. Tracks for row C are supposedly numbered 1 thru 30 beginning at the left end nearest the motor. The 19<sup>th</sup> head location in row C has a missing head and the space is covered with a cover plate having a red ‘X’ marked on it. By removing the cover plate, a visual inspection of this track shows a deep groove has been worn in the magnetic coating. So, this is presumed to be the C19 head mentioned on the blue tag. There are also cover plates over the holes for what would be heads C29 and C30 and the C29 cover also has a red ‘X’ marked on it. The other five rows have cover plates over all the head holes. Measurements show that, if heads were installed in all the locations, each head would be on its own track and tracks are on a 16

track per inch spacing. There are small round tags attached to the electrical lead wires from heads in locations C4, C6, and C8. Markings on those tags are as follows (line breaks as shown on the tag):

C4	C6	C8
Mark Track 1 pulse in phase with TT	Word marks 10 pulses every 84 cells 1 <sup>st</sup> ½ cell from Ref. Mk.	Char. Marks 120 pulses 7 cells apart 1 <sup>st</sup> pulse 1 cell delayed from Ref. Mk.

There are no separate locations to mount timing or marking heads so apparently this function was done within the six by thirty array of heads if all were installed (possibly the tagged C4, C6, and C8 tracks).

The heads on this drum (See Appendix B) are apparently of a newer shorter design although they are very delicate. Each head has a twisted pair of about 28 gauge insulated stranded wire emerging from the top end. Due to handling, all wires are sharply bent at the point of egress from the head and, if they have not already broken off, the remainder soon will also be broken. The wires are 18 inches long and have a taper pin crimped to the end. The heads themselves are round cylinders about ¼-inch in diameter and 0.7 inch long. The head shell appears to be copper or brass. The head is slid into a split and tapered brass holder. The top end is threaded which allows adjustment of the distance of the head gap from the drum. A nut is tightened to hold it in place in its holder once set and there is a red thread-lock material on each. The heads and their holder are clamped in place by two flat head screws which hold the holder mounting surface against the milled case surface. Crude measurements show the current setting for head to drum spacing is probably 1 to 3 thousandths of an inch (published data says this should be 2 thousandths). The magnetic gap end of the head shows the head material is probably a ferrite material about 0.025 inch wide. There is a gap in the ferrite of about 0.002 inch and it is filled with a metal shim. At one end of the ferrite head is the end of a copper bar which is electrically connected to the case (possibly to bleed off static charges). The electrical resistance of the head coil is about 2.5 ohms. The 18 inches of twisted pair wire adds about an ohm to this value. The mounting for these heads appears identical to the milled holes in the model 1119A1 drum discussed previously so it is assumed these same heads were used in that drum.

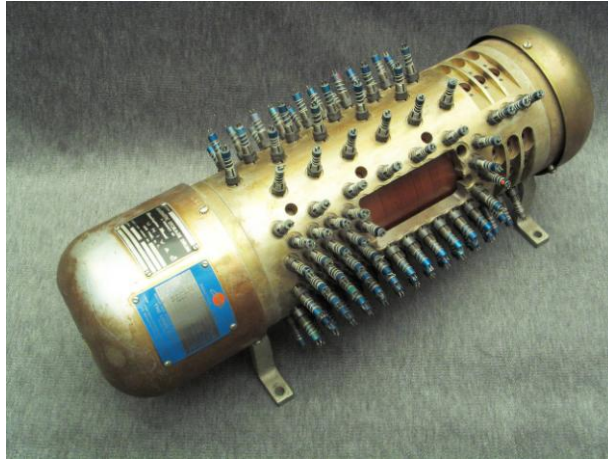
## Model 1124G1, Serial number 4UTA8

See Appendix A for the observed characteristics of this drum and the advertised capabilities of the 1124 family. This drum is in the best condition of the three and is possibly the newest. However the head design is significantly different and, although more durable, is less space efficient. The bearings are in very good condition and the drum will coast for several minutes once set to spinning. This drum has several characteristics that put its purpose into question. The drum itself is highly magnetic, similar to the iron/steel case. Not at all similar to what should be an aluminum drum as claimed in published specs. The case is thicker than the other two drums. Although it has been drilled to accommodate 133 heads, there is a 2 inch by 4 inch cutout where 26 heads would have been. This allows a good view of the drum surface. There are also 3 unused plain 0.4 inch diameter holes, the function of which is unknown. Lastly, is the arrangement of heads - if it were not for the cutout, there would be eight rows of 12 heads, two rows of six heads, and five rows of five heads. Many of these characteristics are visible in the above photo. This drum also has a serial number format not like the other two drums.

According to measurements of head position, each would have a dedicated magnetic track. Opposite the motor end nearest the bearing support end, there are three pairs of 3-head rows (at the right end in the above photo). One pair has heads installed that are the same as other heads on this drum. Another pair is machined in a manner that is similar to those found on the other two artifact drums. In fact, heads from the 1124A1 will fit nicely in these rows. The third-pair are machined in a manner similar to the second head but the head access hole is much larger. It is not known what type of head would be installed in these two rows. All six holes are located where the timing or marker tracks would be. However, it is noted that the head at the far right end is not above a usable portion of the magnetic plating on the drum (this is at the edge of the plated area and shows a white under-plate material).

The heads installed on this drum (See Appendix B) have a magnetic end similar to the heads on the 1124A1 drum and have a ¼ inch diameter aluminum shell but are 2 inches long. Instead of leads coming out the top end, they have a pair of terminals or pins which could receive a small connector. The electrical resistance of the head coils measures about 2.5 ohms, the same as the smaller heads. The magnetic end of the head is similar to that of the short heads except the copper bar at the end of the ferrite does not appear to have any electrical connection to coil or case. The case covers more of the end of the head and possibly that alone provides any protection from static charges. The heads are slid into a

split cylinder which is press fit into the casing. There is a threaded collar which can be tightened to squeeze the head and hold it in place. A spring mounted around the head will push the head out of the drum if the collar is loosened. The heads have a raised dimple(s) on the side of the body which allows the head to be inserted into the split cylinder in only four possible orientations. This would force the head to be either in line with the track or 90 degrees out of position. As received, all heads were fully retracted away from the drum surface so it was not possible to determine a head to drum surface spacing. The method of mounting these heads takes up much more room than that used in the other two drums thus the potential head density is lower. It has been stated that the heads are this long because this was the length of the heads on the first drums, thus they took no more space. Supposedly the short style heads are a newer innovation which takes less space. But this argument is contrary to the apparent date of manufacture of the drums.

This drum weighs significantly more than the other two due to the apparent ferrous drum and thicker iron/steel casing. One theory is that this was a drum used in an airborne application and needed to be more rugged. Another theory is that it is a marketing display model (for RRU in New York) showing various options that are available for potential applications.

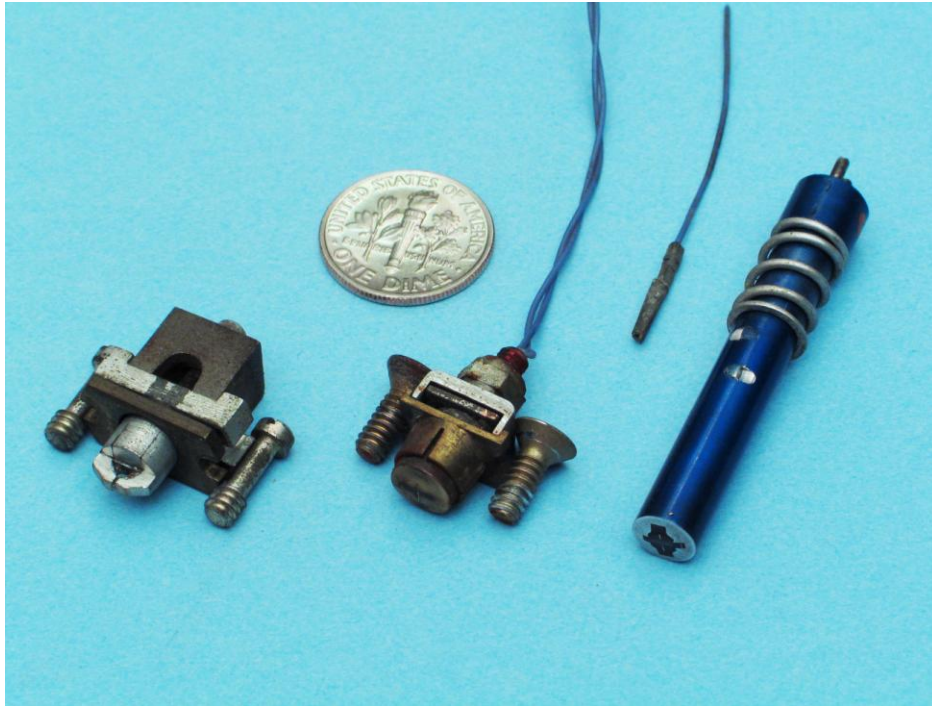
Photo B1 – Three types of heads. From left to right: Permanent magnet head with mounting screws, short head with twisted pair wires and with holder and mounting screws, one wire with taper pin termination, long head with spring.

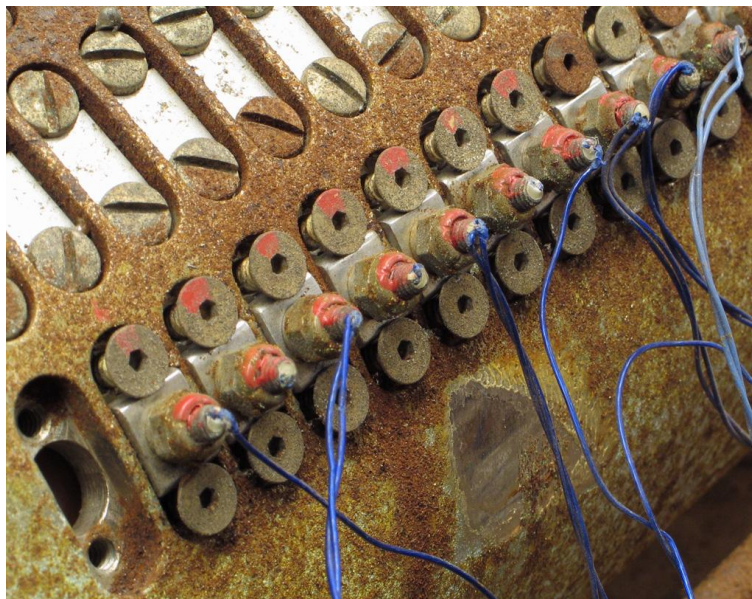
Photo B2 - Small head mounting on 1124A1 drum. Also shows cover plates on unused locations as well as an open hole with head removed at position C1.

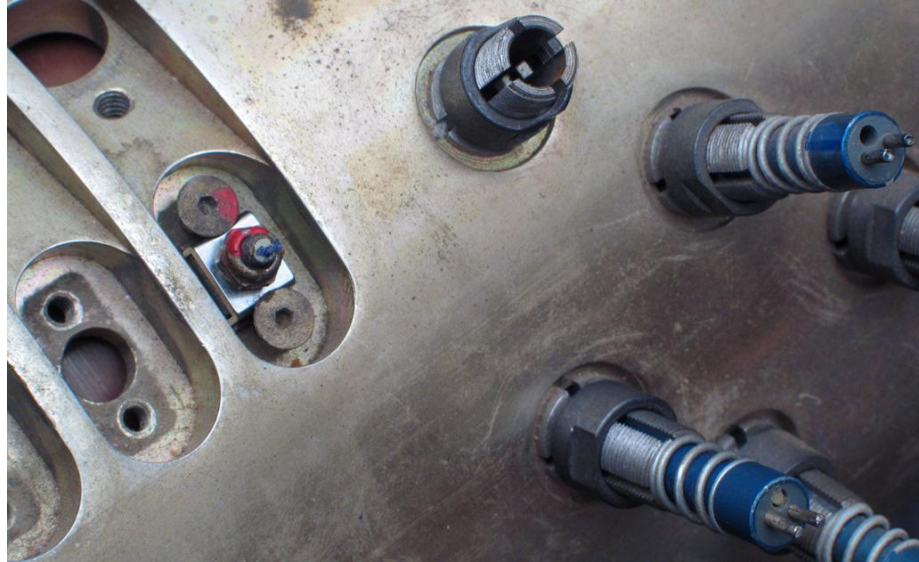
Photo B3 – Large head mounting on 1124G1 drum, one where the head has been removed. Also shows a small head from the 1124A1 drum installed into one of the auxiliary mark/timing track locations.

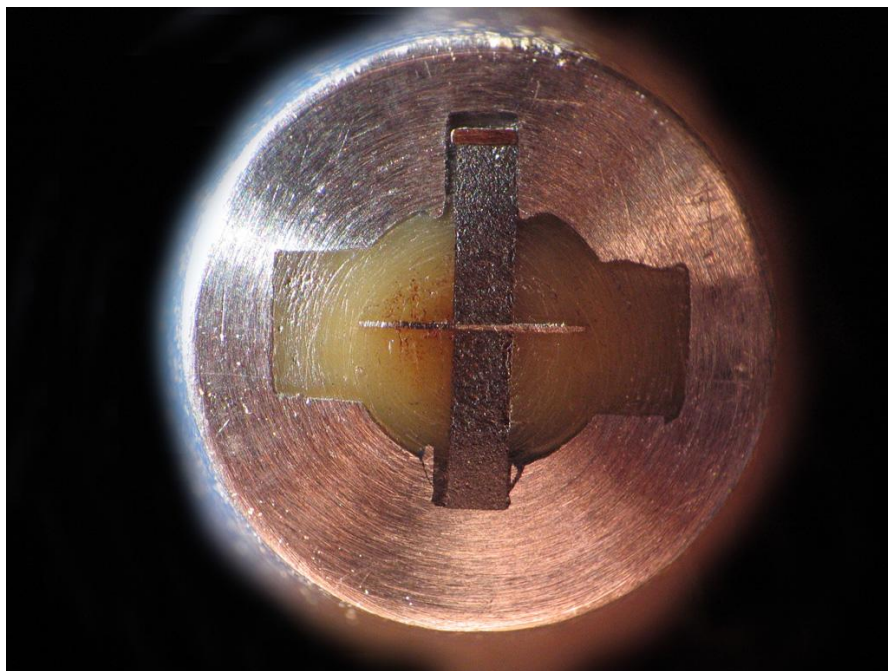
Photo B4 – Typical magnetic operating end of a long head as found in the 1124G1 drum. Note: the copper color is due to the ambient light, not the color of the metal except for the end of the copper bar at top of the ferrite. True case color is aluminum as shown at the top left of the photo. The small heads are slightly different in that the case does not cover as much of the end as is shown here.
